# Sub-Basin Urbanization and Habitat Characteristics

## Blanco River Sub-Basins

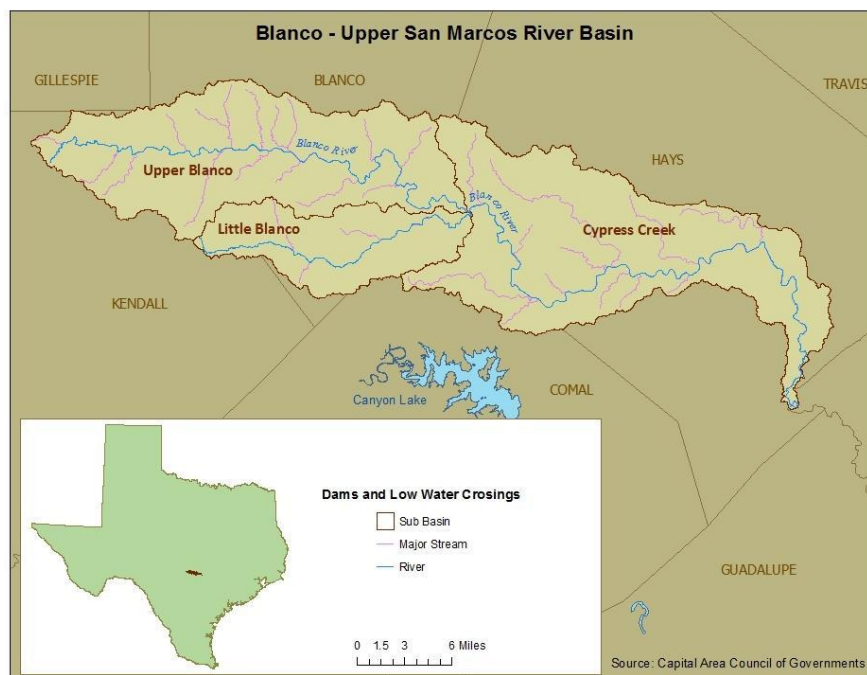
Figure 45 Blanco River Basin Sub-basins.

The Cypress Creek sub-basin is at the easternmost or terminal portion of the Blanco Basin, while the Upper Blanco comprises the western portion of the basin where the headwaters are located and the Little Blanco contains a major tributary and is south of the Upper Blanco sub-basin.

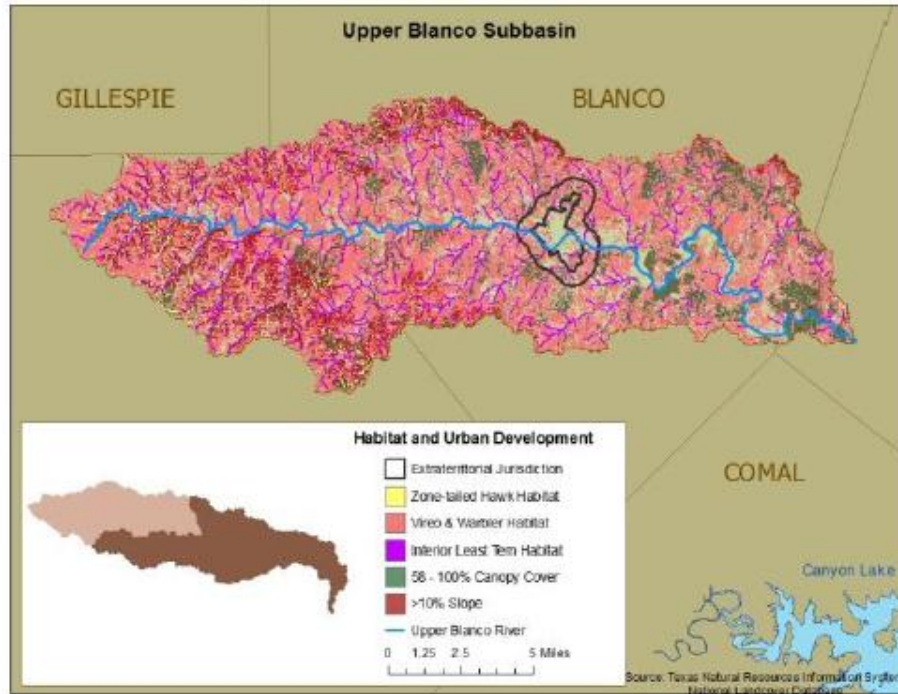
Figure 59 Upper Blanco Basin Selected Bird Habitats and ETJs.

The majority of land associated with wildlife habitat in the Upper Blanco Basin is concentrated along the central northern basin border, as well as the southwestern portion of the basin and along riparian corridors, well away from the ETJ of the city of Blanco (Figure 59). Small stands of trees and riparian habitat downstream of Blanco should be monitored for effects from increasing urbanization in the form of non-point source pollution run off and changed overland flow patterns.

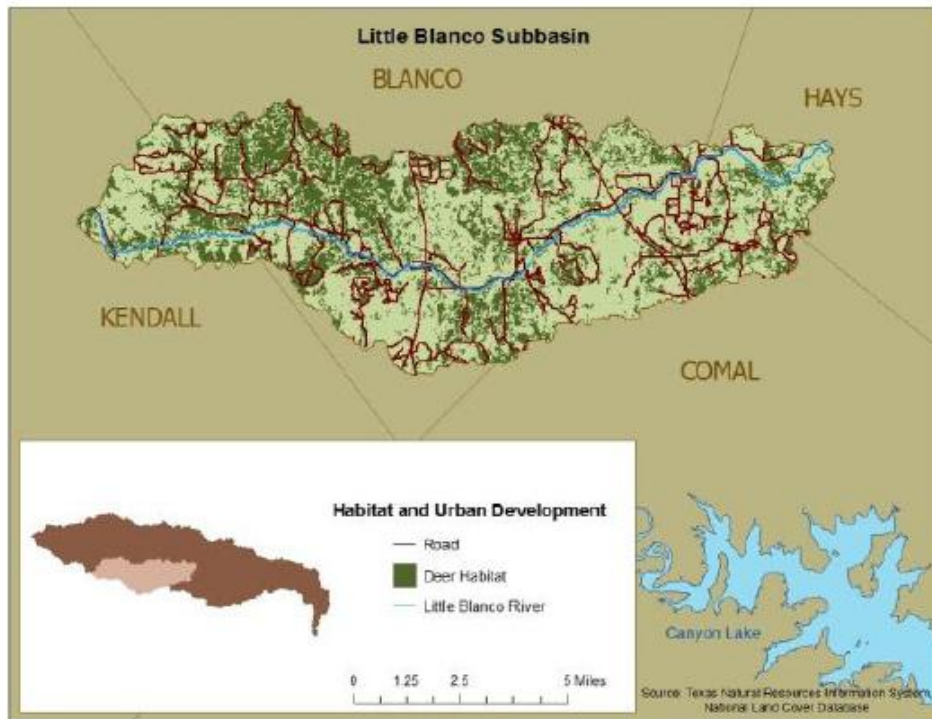
Figure 61 Little Blanco Basin Deer Habitat Fragmentation

Following the trend exhibited throughout this sub-basin, the Little Blanco shows little interface between its vast habitat areas and urban development (Figure 61). The northern edge and north western portion of the basin host the greatest habitat areas with little disturbance. Their condition has remained primarily intact due proximity to steep slopes less suited for development and lack of road access. However, several roads intersect the basin and occurring development is likely to follow those road paths, which could lead to habitat fragmentation and increased urban interaction.

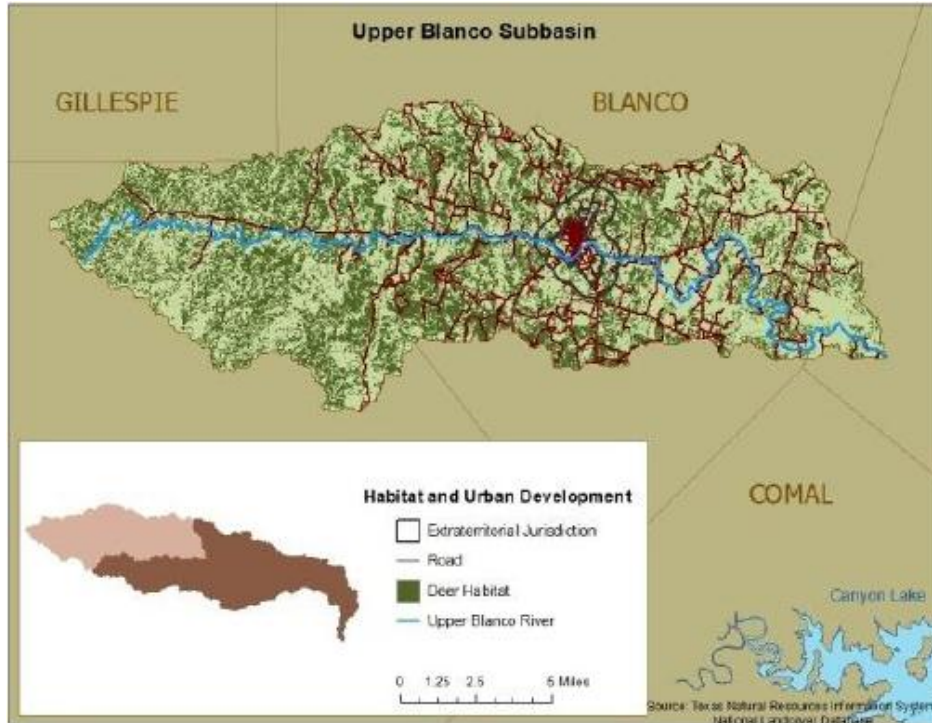
*Figure 62 Upper Blanco Basin Deer Habitat Fragmentation*

The Upper Blanco Basin also follows the acknowledged trend of urbanization centered around the city of Blanco, with the majority of the roads constructed in the central portion of the basin (Figure 62). In this area, habitat is highly fragmented, but remains intact and relatively undisturbed in the western third of the basin. Development should be carefully managed in this area to minimize future disturbance and fragmentation.
